CONFIDENTIAL INSPECTION REPORT

38 W Wilson Ave, Lombard, IL 60148

5/18/2008 8:00 am to 11:00 am

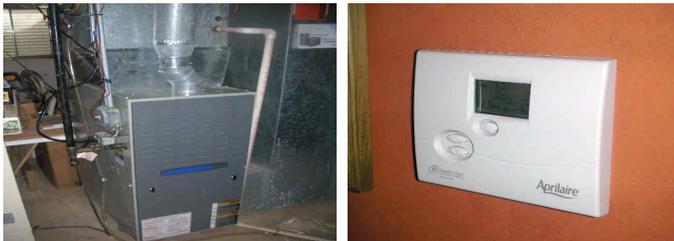
Central heat and air-conditioning are provided by dual systems, consisting of two 8 year-old furnaces with evaporator coils that are located in basement and two 8 year-old condensing coils that are located on the outside.

The split-system is in the mid-range of its design life and will need to be more closely monitored, serviced bi-annually, and should have its filter changed every two to three months.
